BRANDEGEE LAKE DAM
CT. 00153

PHASE I INSPECTION REPORT
NATIONAL DAM INSPECTION PROGRAM

JUNE 1981

THAMES RIVER BASIN
WATERFORD, CONNECTICUT

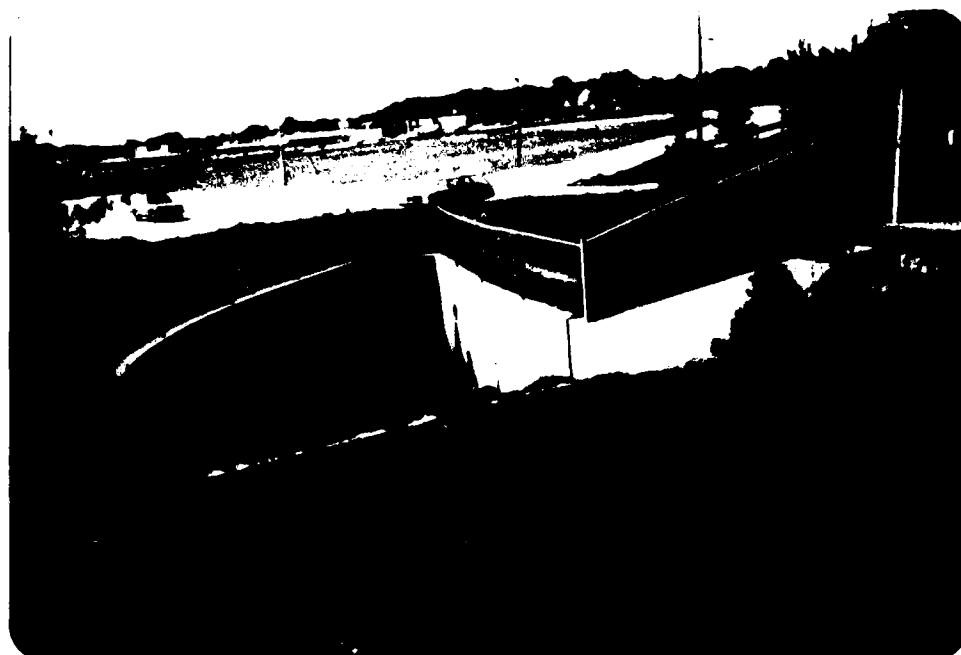
1. Spillway. The spillway is located 100 feet to the right of the left abutment and is 28 feet wide with a crest elevation of 129.5 NGVD (Photos C-7 and C-8). The spillway discharge channel was resurfaced in 1972 with concrete and a culvert was constructed which carries all discharges to Perry Pond located 1500 feet downstream (Photo C-7). The concrete paving of the channel has a misaligned construction joint approximately 20 feet downstream from the crest. The downstream slab at this joint is approximately 1/2 inch higher than the upstream slab (Photo C-8). This joint should be observed in the future to determine if movement is occurring.

PHOTO C-7. Spillway crest, discharge channel and culvert. Seepage through the left training wall is visible as a wet area just upstream from entrance to the culvert near the floor of the channel.

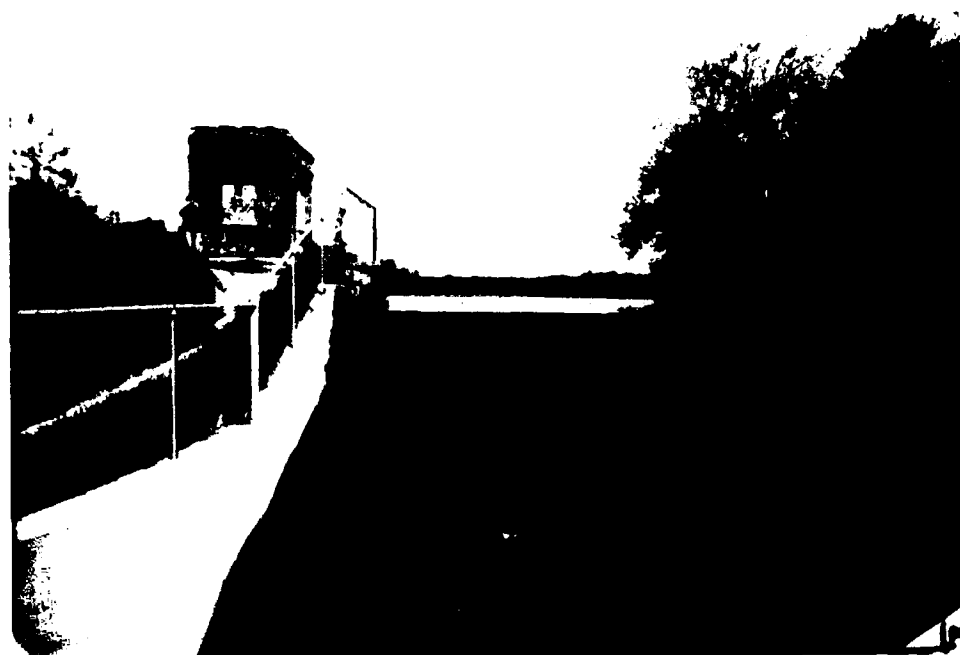
PHOTO C-8. Spillway and discharge channel from downstream. Note the vertical displacement of the construction joint in the floor of the channel.

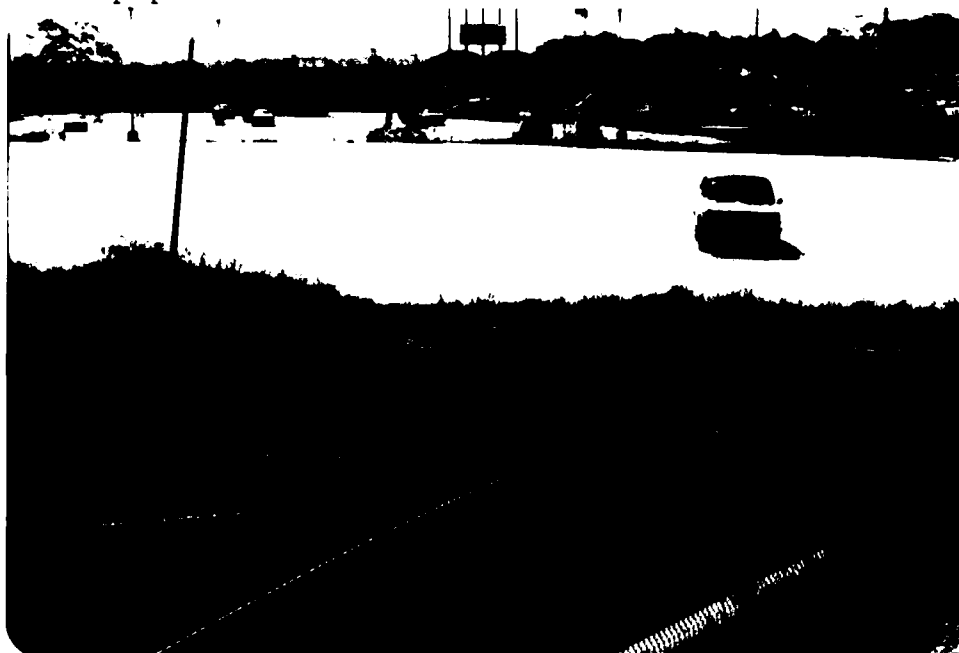
PHOTO C-10. Downstream area below dam with spillway discharge channel in the foreground. Note the two parking lots and Route 95 Fontage Road which are located in the dam failure impact area.
